D. Roof Covering

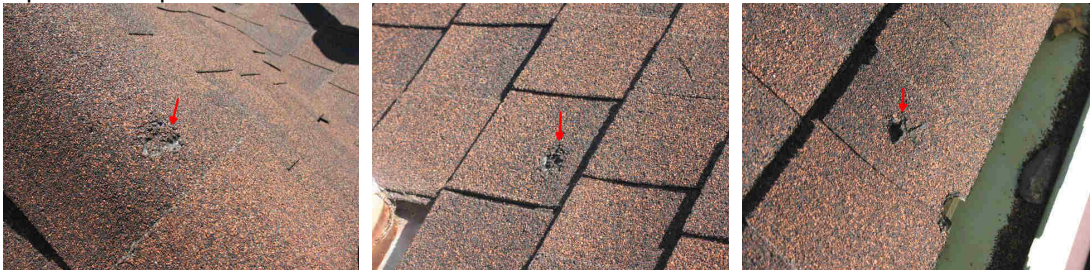
1.2. Dwelling roof covering is showing evidence of widespread hail impact damages with damages noted to shingles including bruising & aggregate loss. Due to widespread hail damages, age & brittleness of roof covering and it is the opinion of this inspector that roof is not a candidate for spot repair, has reached the end of its serviceable life and needs to be replaced. All roof layers should be removed, replace any defective or damaged sheathing as required, re-flash, refelt when installing new roof covering. A qualified roofing contractor should make all needed repairs as required.

(all areas are not shown in photos)
